# UNDERCONSTRUCTION GENERATION PROJECTS OF NEPAL ELECTRICITY AUTHORITY

# NEA INVOLVED UNDER CONSTRUCTION PROJECTS

# CHAMELIYA

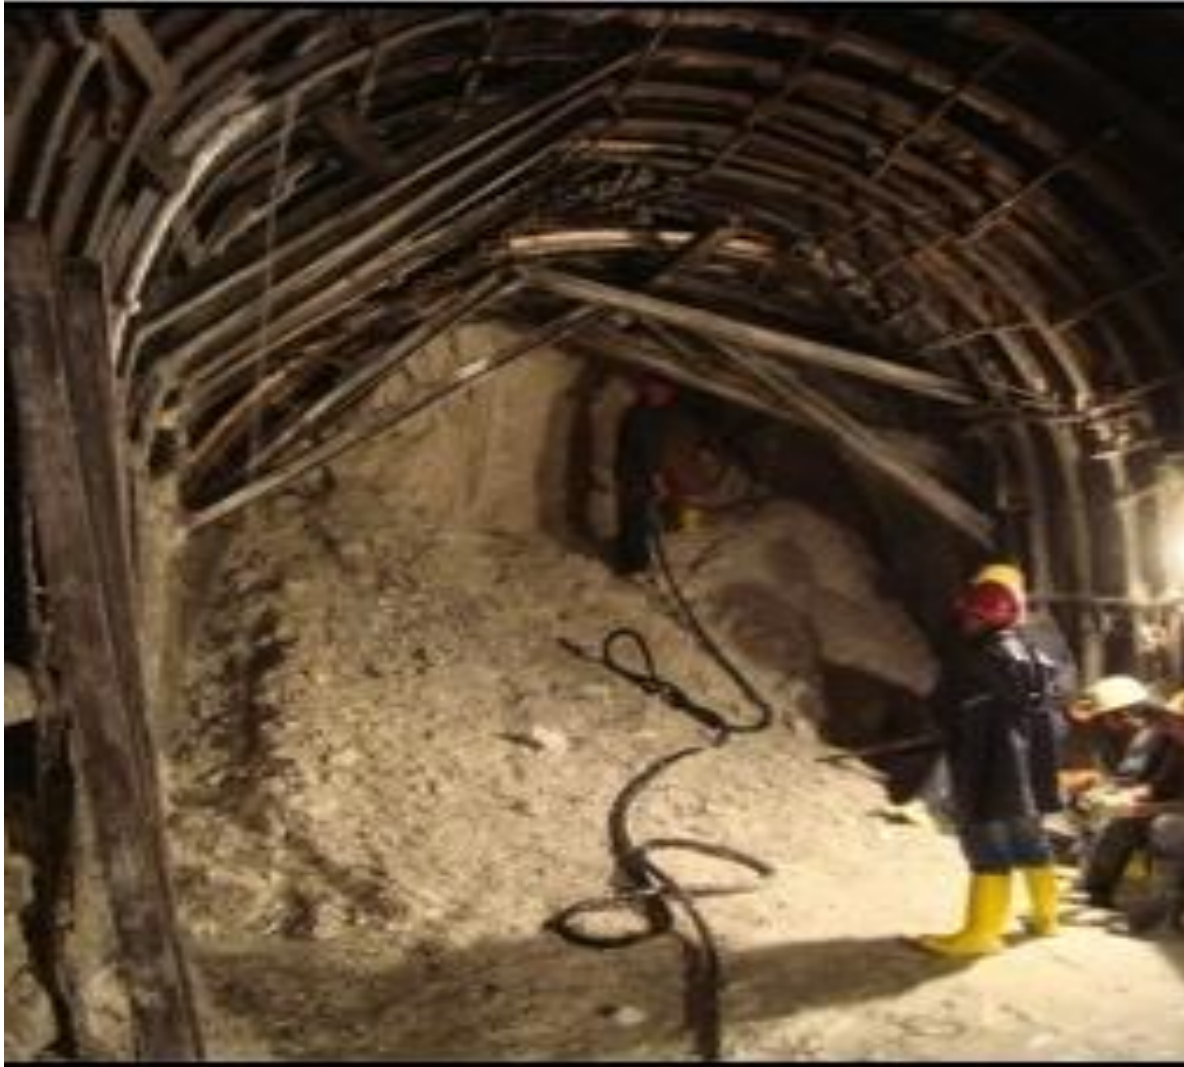
## TUNNEL SQUEEZING

- Completed above 95%.
- Faced various geological problems resulting in time and cost over run.
  - Hard rock in dam foundation not as expected.
  - After excavation of complete 4.6 km tunnel, 843 m got squeezed.
  - Mud flow from nearby rivulet Bhelgad entered the tunnel.
  - Original location of Power house foundation was in alluvium so shifted back by huge back slope cutting and its stabilization.
  - Cavities encountered on the sides of vertical shaft.
- Chameliya can be taken as unique example of geological problems.

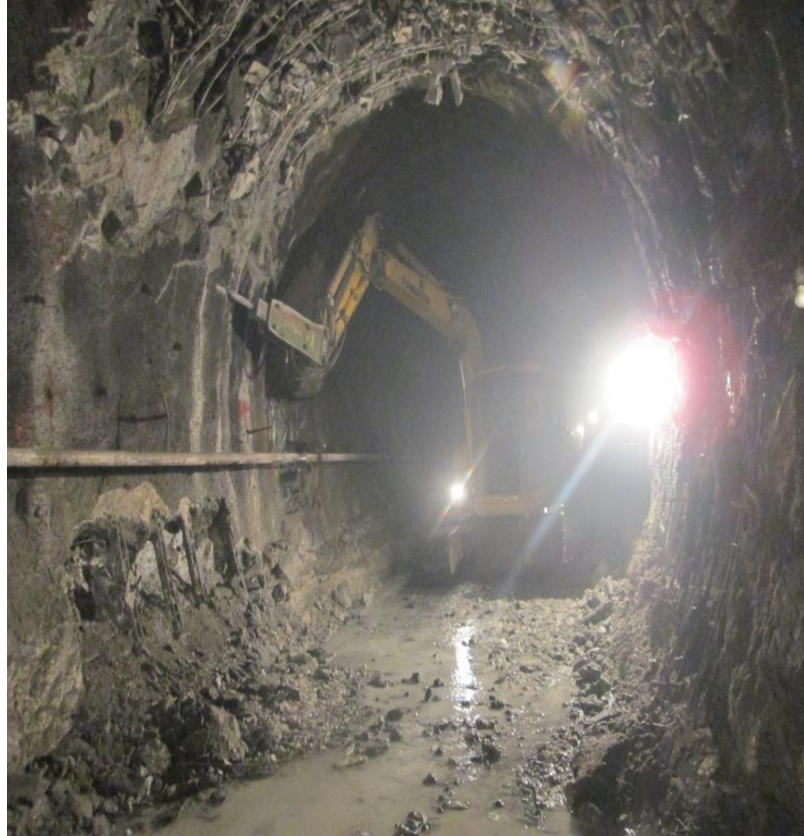
**BREAKING BY MACHINE**

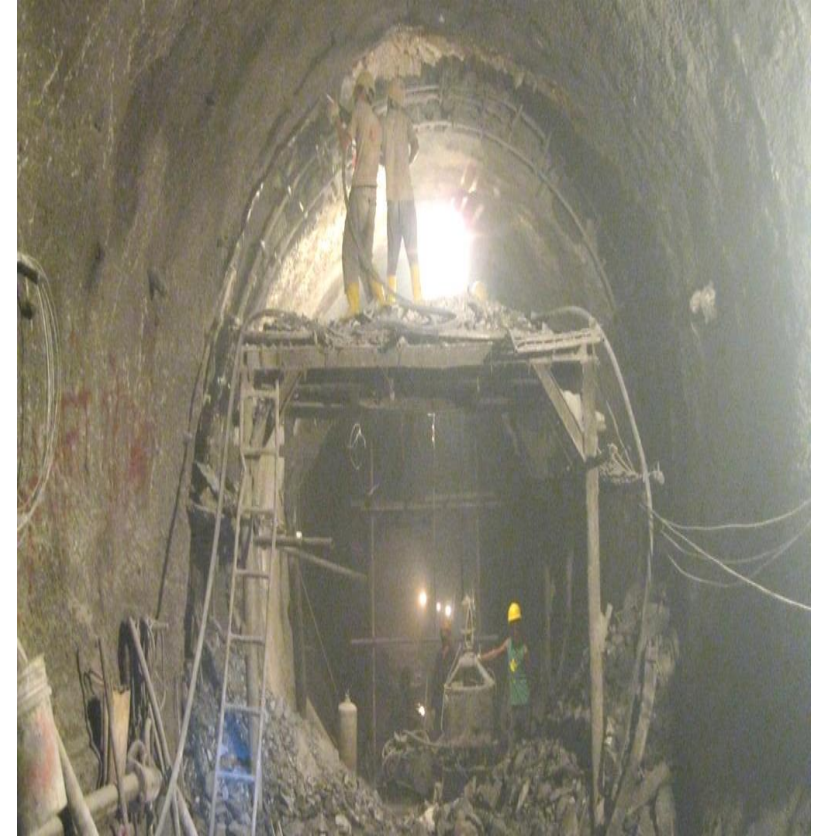
**BREAKING MANUALLY**

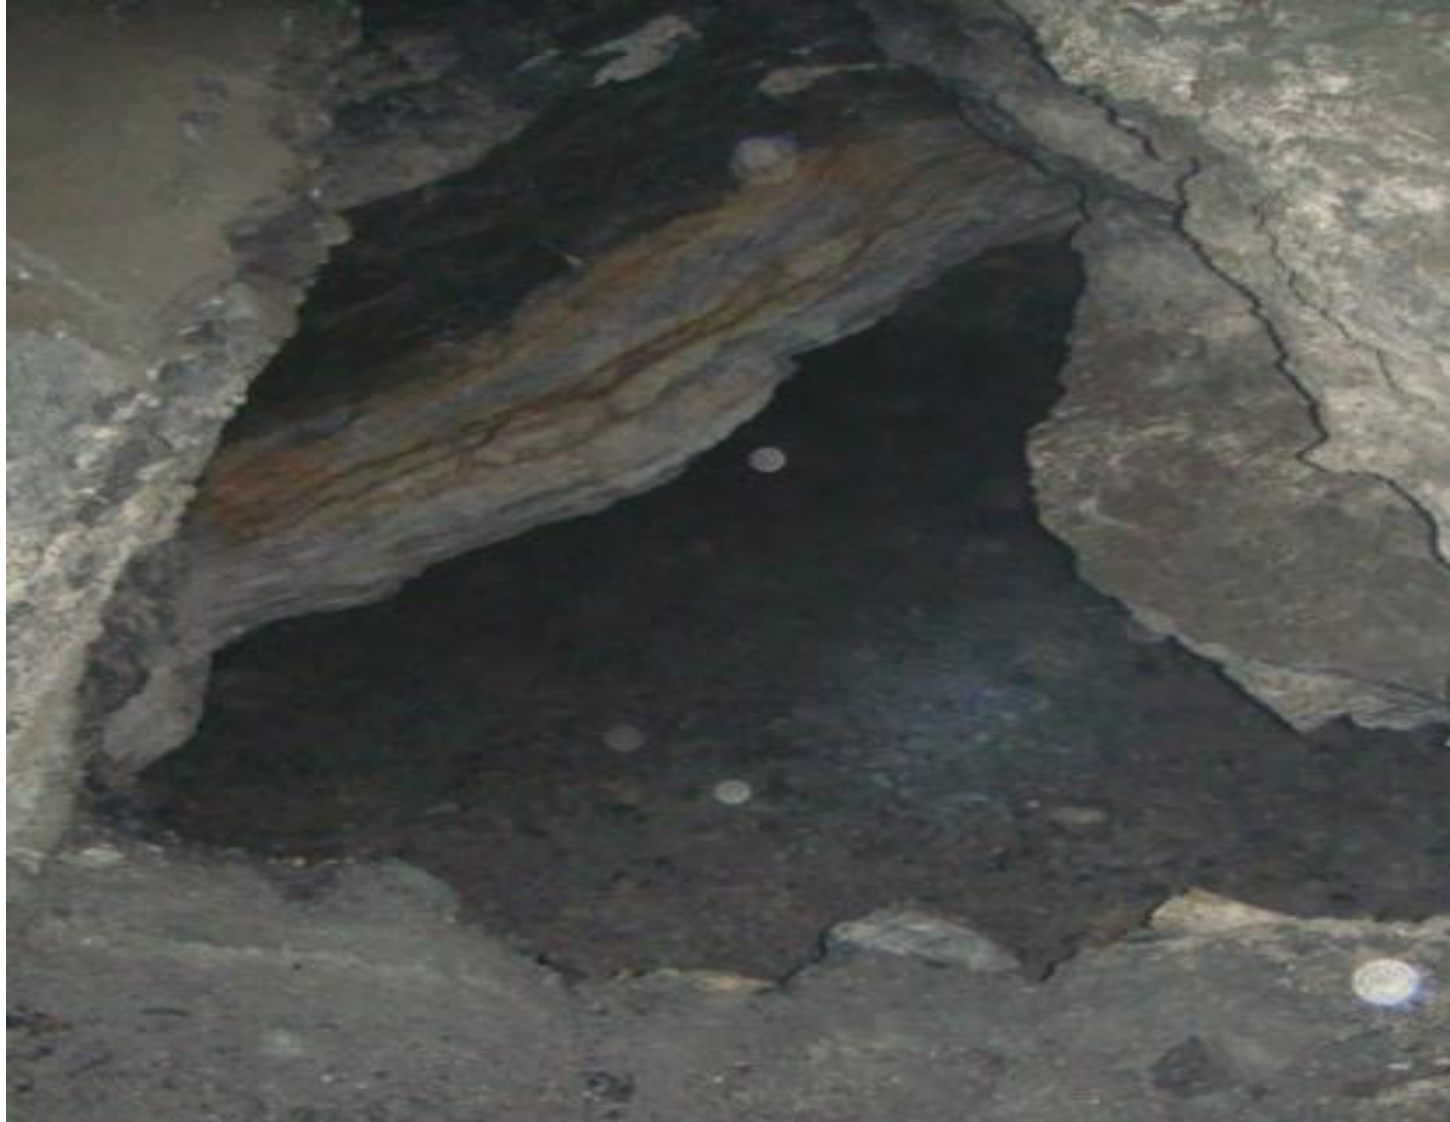
# VERTICAL SHAFT

- Large cavity around shaft
  - Approx. 25 x 8 x 5 m
  - Crushed material
